Innovative Housing Grants Program

SETBACKS FROM SLOPE CRESTS FOR STRUCTURES

March 1991

D. M. CRUDEN AND J. S. DE LUGT
University of Alberta

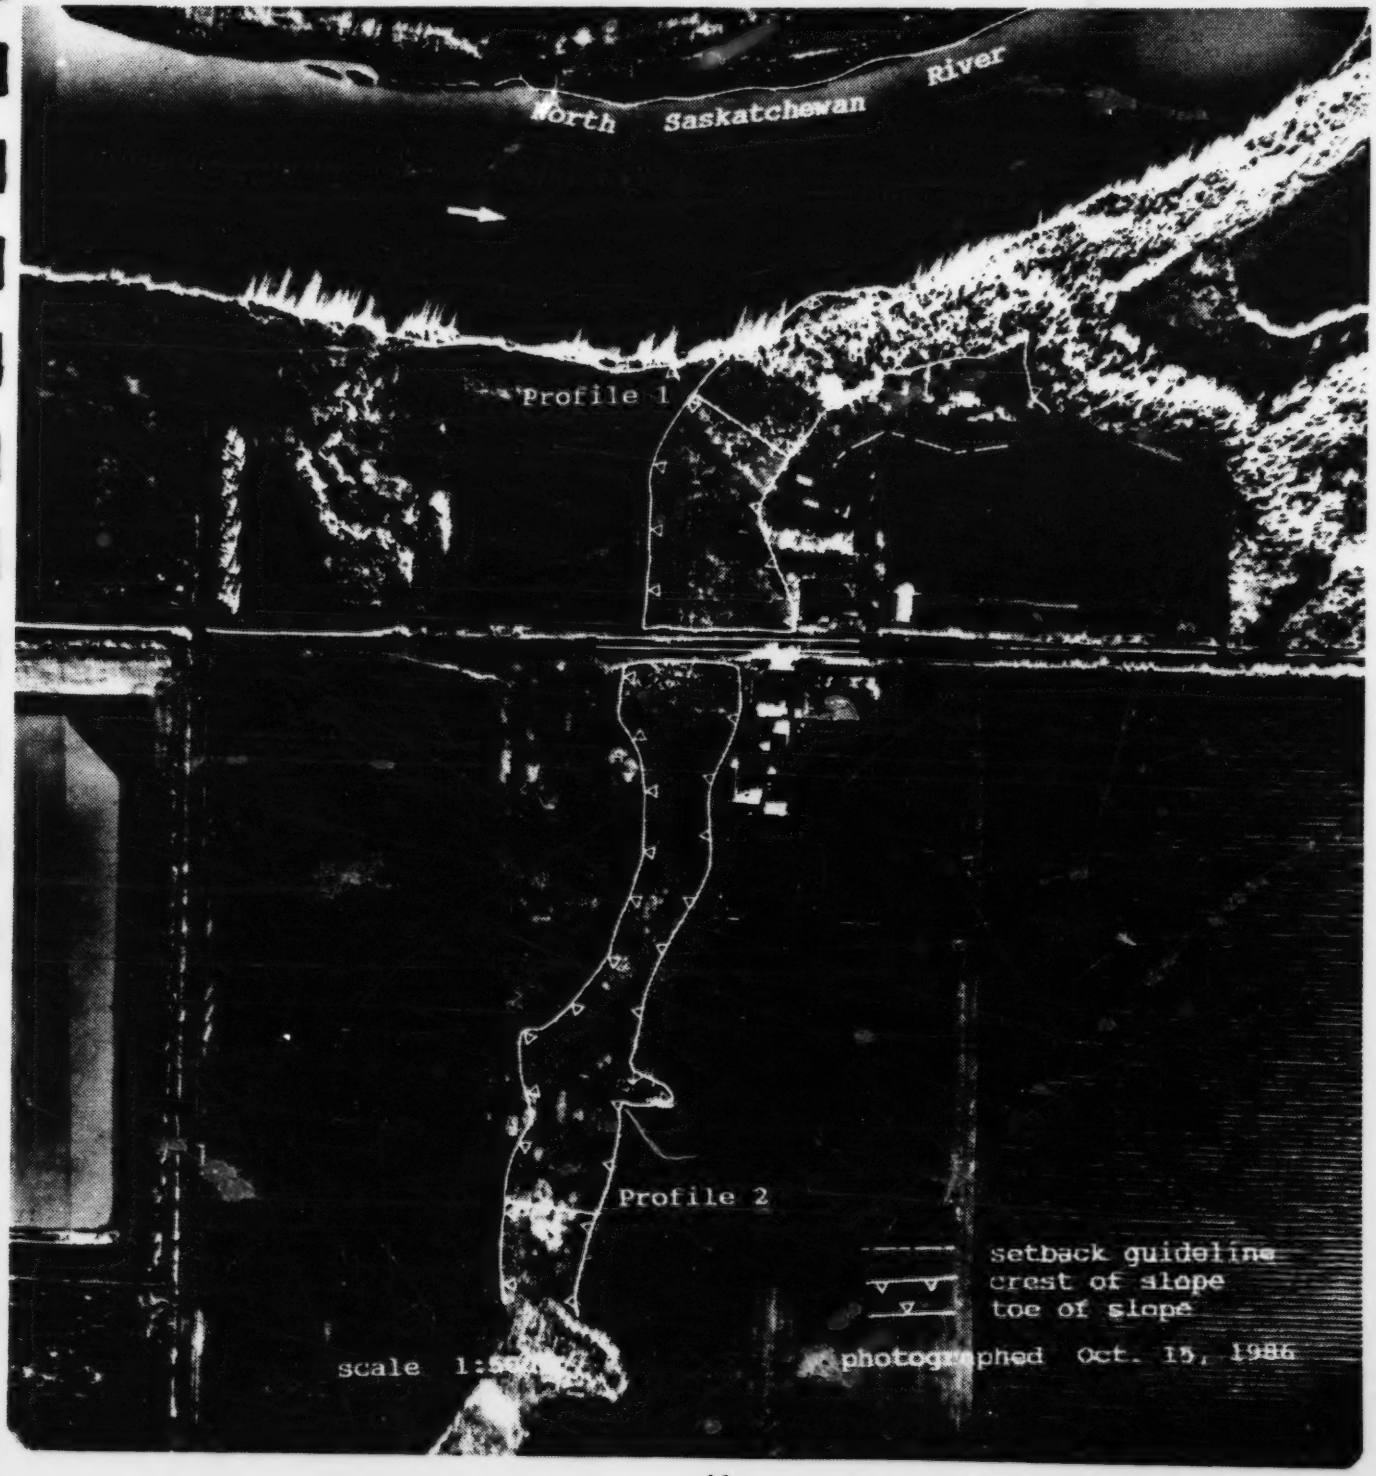
Figure 5: Setback Guideline for the Lesueur Landslide

In the 24 years since the slide occurred, the crest of the scarp retreated a total of about 23 m suggesting that 67 m is a conservative, but reasonable setback estimate. Figure 5 indicates the setback generated by the model, and its effect on land use in the immediate vicinity of the landslide. Accordingly, development above the valley wall might be restricted for an area of about 9,000 m^2.

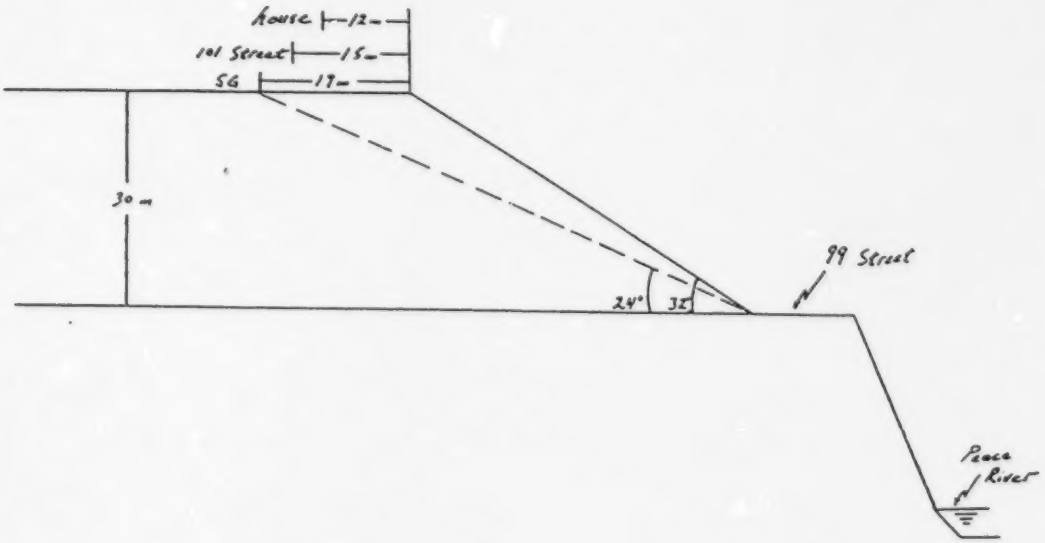
101 Street Slide, Peace River Town

Hs - slope height = 30 m (Barlow et al., 1990)

ßu - ultimate angle of stability = 24°

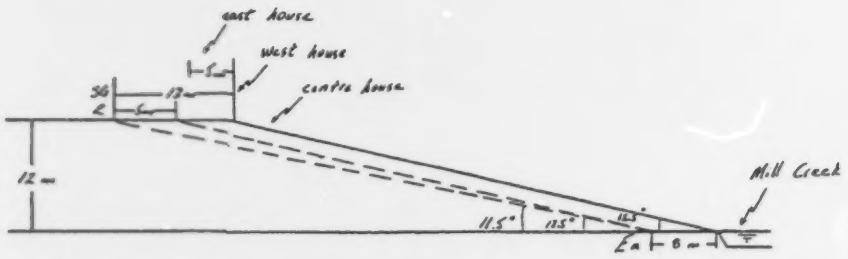
76th Ave. at Mill Creek, Edmonton

Hs - slope height = 12 m (orthophoto measurement)

ßu - ultimate angle of stability = 11.5°

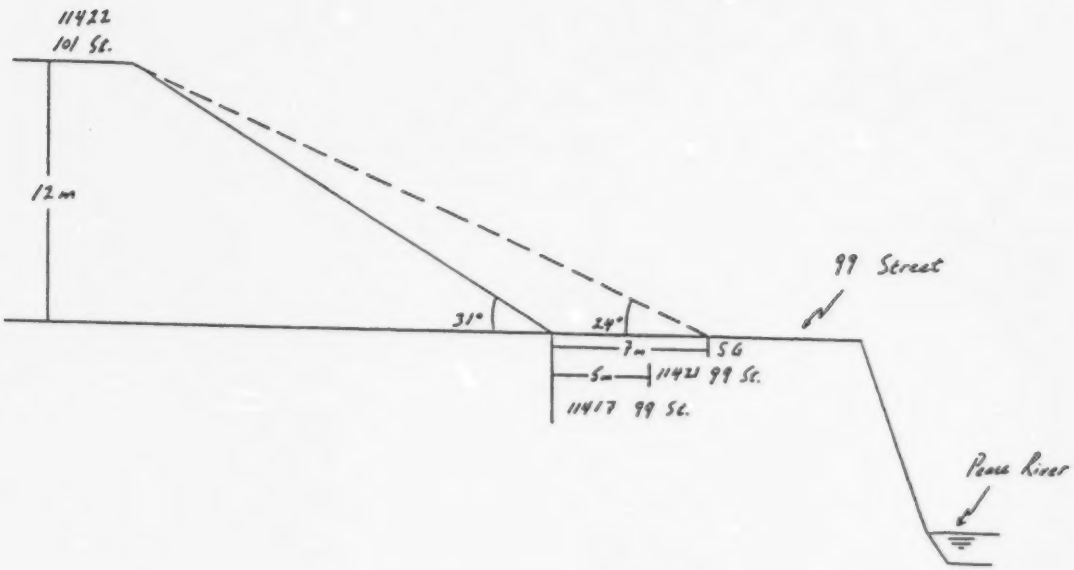
99 St. Slide, Peace River Town

Hs - slope height = 12 m (orthophoto measurement)

ßu - ultimate angle of stability = 24°

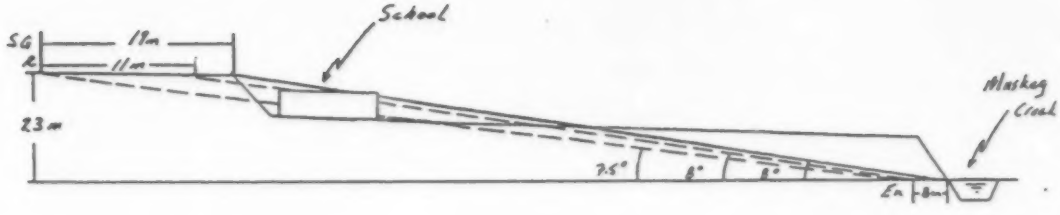
Athabasca Elementary School Slide

Hs - slope height = 23 m (Hardy R.M. and Associates, 1970)

Bu - ultimate angle of stability = 7.5°

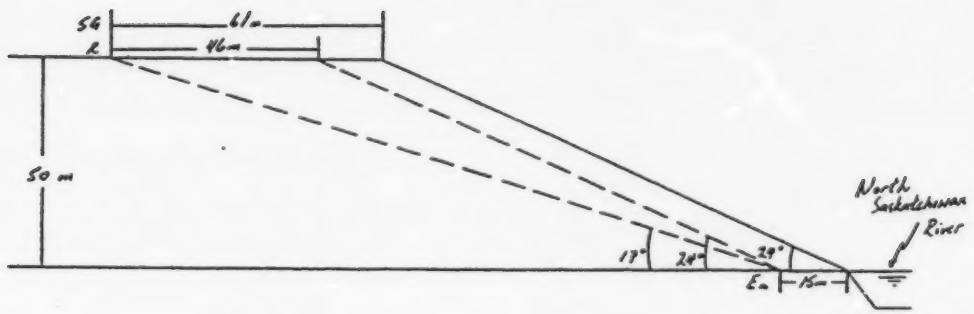
Grierson Hill Slide, Edmonton

Hs - slope height = 50 m (Poppitt, 1963)

ßu - ultimate angle of stability = 17°

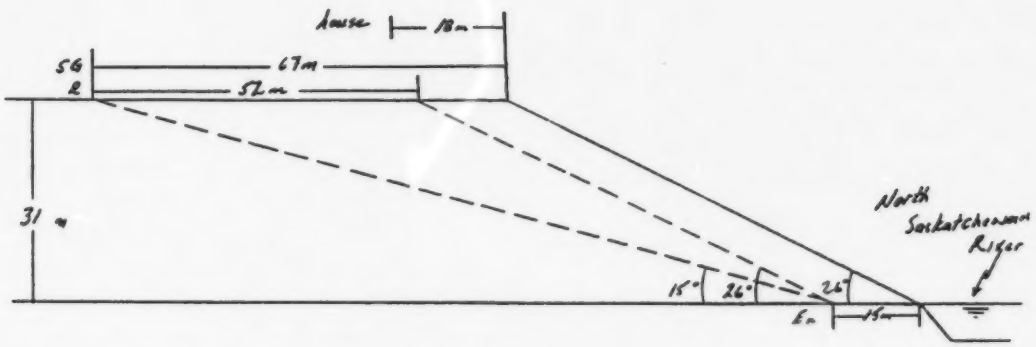
Lesueur Slide, North Sask. R., Edmonton

Hs - slope height = 31 m (Thomson, 1971)

ßu - ultimate angle of stability = 15°

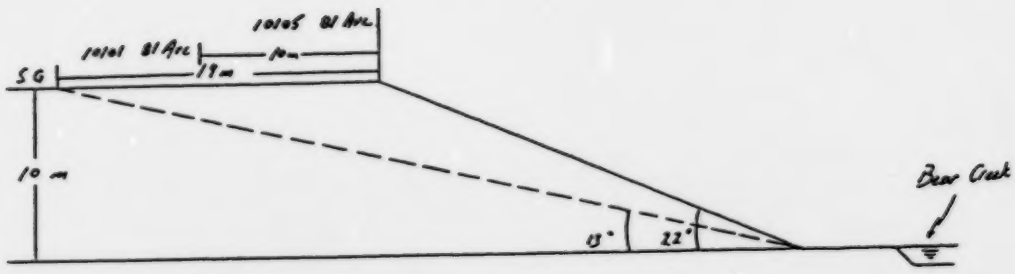
Mission Heights, Grande Prairie

Hs - slope height = 10 m (orthophoto measurement)

ßu - ultimate angle of stability = 13°

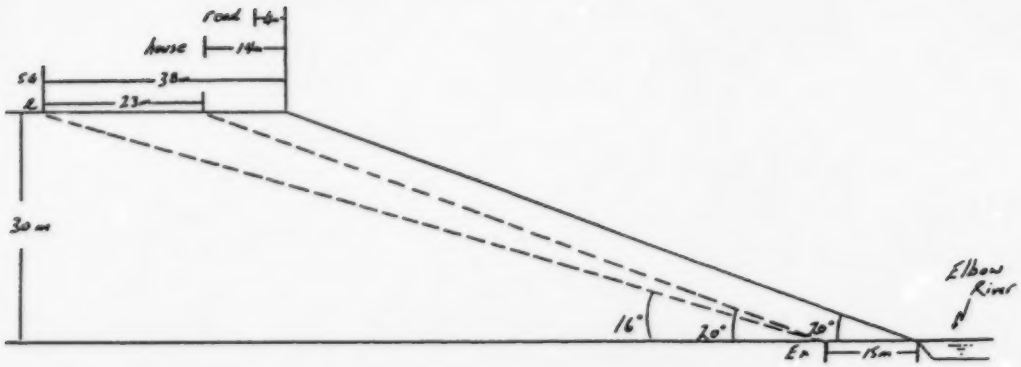
Park Hill Slide, Calgary

Hs - slope height = 30 m (Hardy et al., 1980)

$\bar{B}u$ - ultimate angle of stability = 16°

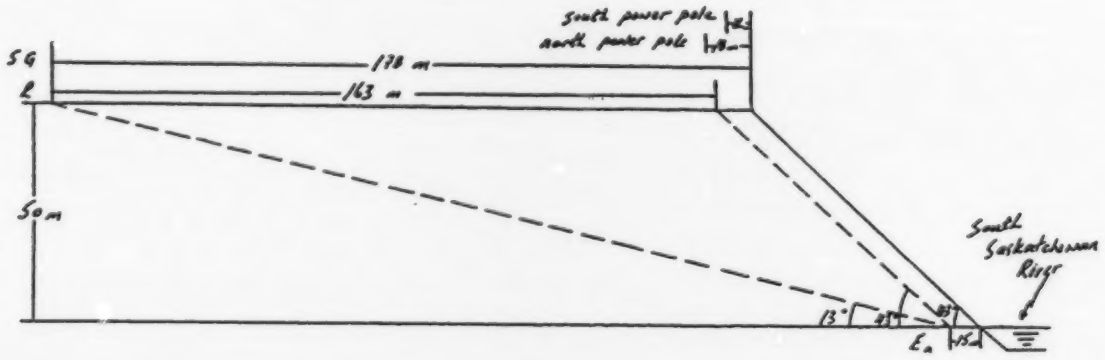
Power Plant Slide, Medicine Hat

Hs - slope height = 50 m (MacKay and Thomson, 1980)

ßu - ultimate angle of stability = 13°

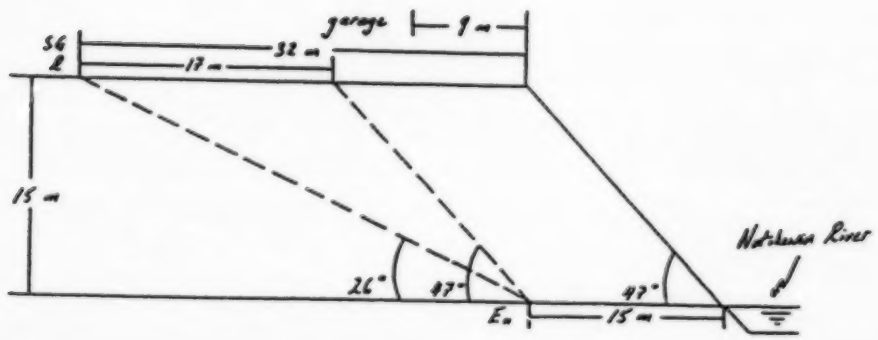
Schoendorfer Slide, Manning

Hs - slope height = 15 m (Surveys and Mapping Branch, 1976)

ßu - ultimate angle of stability = 26° (field measurement)
